Reference: Report of Limited Geotechnical Exploration
Town of Tyrone – 2024 Pavement Evaluation
Tyrone, Georgia

ECS Project Number 10:12117

SITE LOCATION DIAGRAM
TYRONE - 2024 PAVEMENT EVALUATION
 TYRONE, GEORGIA
POND & COMPANY

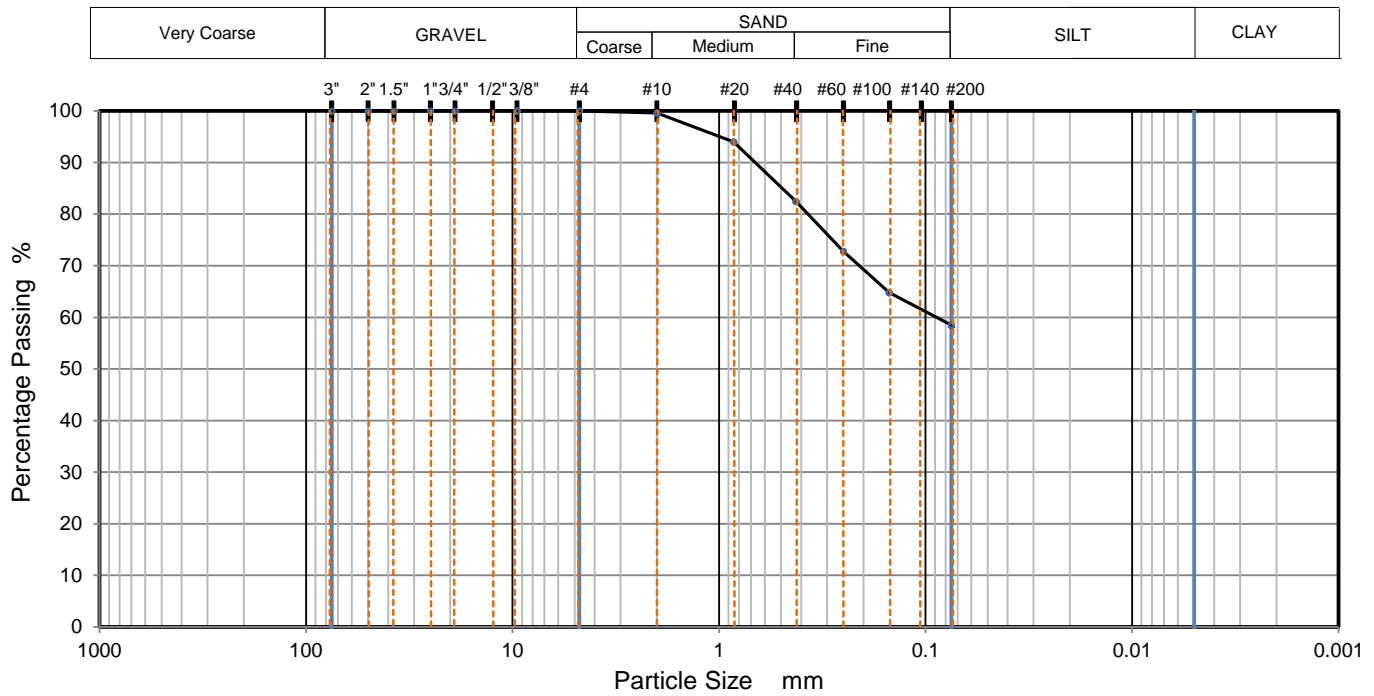
PARTICLE SIZE DISTRIBUTION

Sieving		Hydrometer Sedimentation	
Particle Size	% Passing	Particle Size mm	% Passing
3"	100.0		
2"	100.0		
1 1/2"	100.0		
1"	100.0		
3/4"	100.0		
3/8"	100.0		
#4	100.0		
#10	99.6		
#20	94.0		
#40	82.5		
#60	72.8		
#100	64.8		
#200	58.5
